DEPARTMENT OF TRANSPORTATION**DIVISION OF ENGINEERING SERVICES**

Quality Assurance and Source Inspection

Blast shop #4, Segments 13AW, 13BW and 13CW

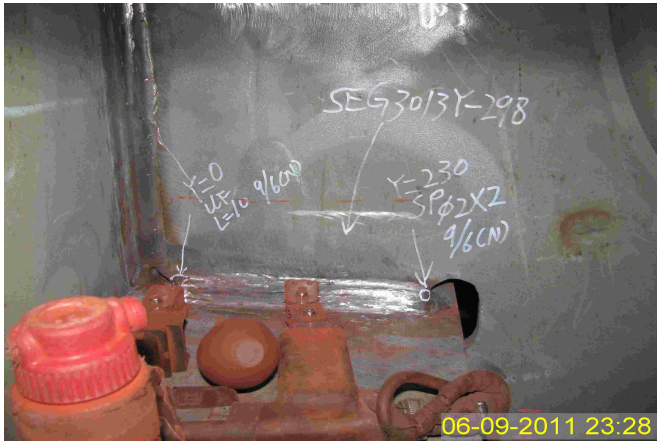
and items observed by this QA Inspector appeared to comply with AWS D1.5 MT requirements. This QA Inspector provided a turnover to dayshift personnel for tracking of these welds. For additional information on these inspections see this QA Inspector's TL6028 Magnetic Particle Test Report and the photograph below.
